Important E20 Information

OPERATION
June 2, 1971

Subject: Elec-Trak E-20

To: All Elec-Trak Dealers (Supersedes issue dated May 21, 1971)

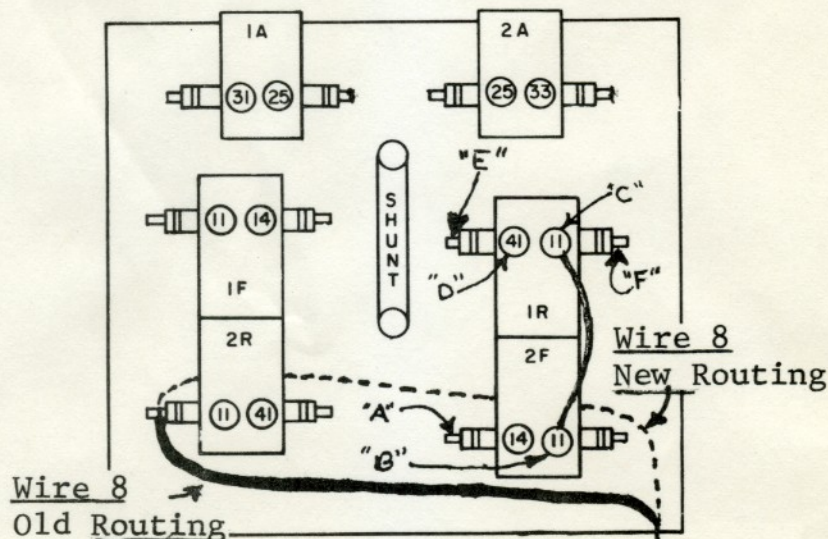
Figure 1. Lower Control Panel

1. Identify heavy wire #8 connected to the left side of 2R contactor (See Figure 1).

1. Identify wire #6-01-6 (14 gauge) connected to the left side of 2F contactor (See "A" of Figure 1).
2. Cut this wire as close to its terminal as possible and strip wire and crimp on a new ring terminal suitable for a 14 AWG wire and a #10 stud. (Part identification number 34123 in your Wire Terminal Kit.)
3. Add this wire to the right coil stud of 2F contactor which presently has a wire coded #11 connected to it. (See point "B" in Figure 1.)
4. Check to see that jumper wire #11 is connected between points "B" and "C" as shown in Figure 1. If it is found to terminate at point "D" make the correction as required.
5. Mask wire code 6-01-6 with tape or other suitable means and renumber this wire "11".
6. Renumber the other end of wire 6-01-6 in the same fashion. This end is connected to 3A contactor coil which is located on the upper control panel just above 2A contactor.

4. Install wire number 60 (supplied) on pad 7 of card No. 3 and terminate its other end on the left side of 1R contactor, point E in Figure 1.
5. Install wire number 24 (supplied) on pad 1 of card No. 3 and terminate its other end on the right side of 1R contactor, point F in Figure 1.

2. Remove wire #8 and re-route it behind 2F and 2R contactors making sure it cannot touch the shunt.
3. Reconnect wire at its original connection point on 2R contactor.
